UNITED STATES ENVIRONMENTAL PROTECTION AGENCY  
REGION 5  
77 WEST JACKSON BOULEVARD  
CHICAGO, IL 60604-3590

RE: Mandarin Oriental Site  
130 East Lake  
Chicago, Illinois

U.S. EPA has reviewed our radiological walkover measurements taken September 28 and 29, 2006, at the Mandarin Oriental Site at 130 East Lake Street in Chicago, Illinois as well as the information in the letter from Vincent S. Oleskiewicz dated October 11, 2006, regarding that property, and four reports prepared by EPS Environmental Services, Inc. The reports prepared by EPS were as follows:

EPS Environmental Services, Inc. (EPS Environmental) has performed a Phase I Environmental Property Assessment (Phase I Assessment) in conformance with the scope and limitations of ASTM Practice E 1527-97 of one acre of vacant land located at the northwest corner of East Lake Street and North Sietson Avenue in Chicago, Illinois (Property). Any exceptions to, or deletions from, this practice are described in Section 2.3 of this report. This Phase I Assessment has revealed no evidence of recognized environmental conditions in connection with the Property except for the following:

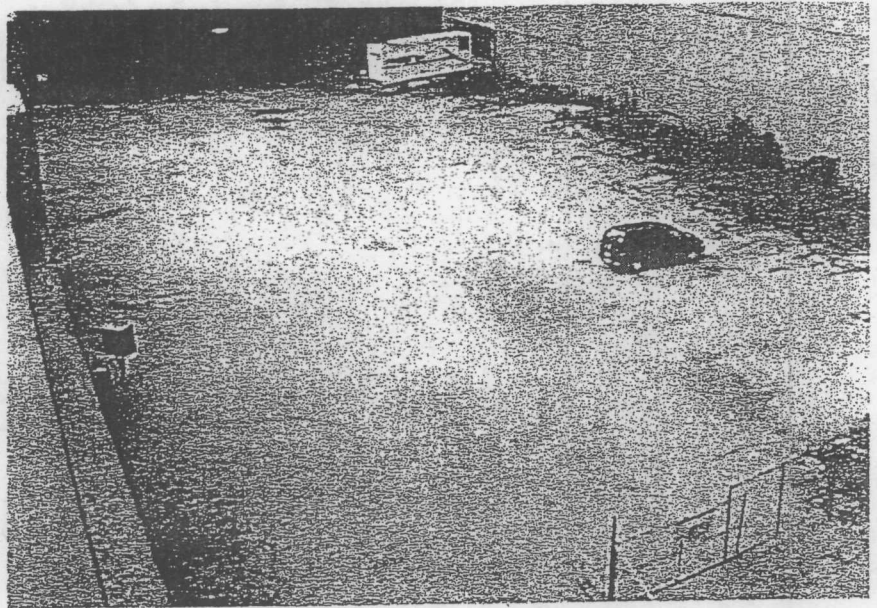
The Property consists of a grass and gravel-covered, approximate one (1) acre parcel of land situated approximately 40 feet below street level. A building foundation was observed extending from the eastern Property boundary towards the center of the Property.

Right and Below: Views of the  
Property

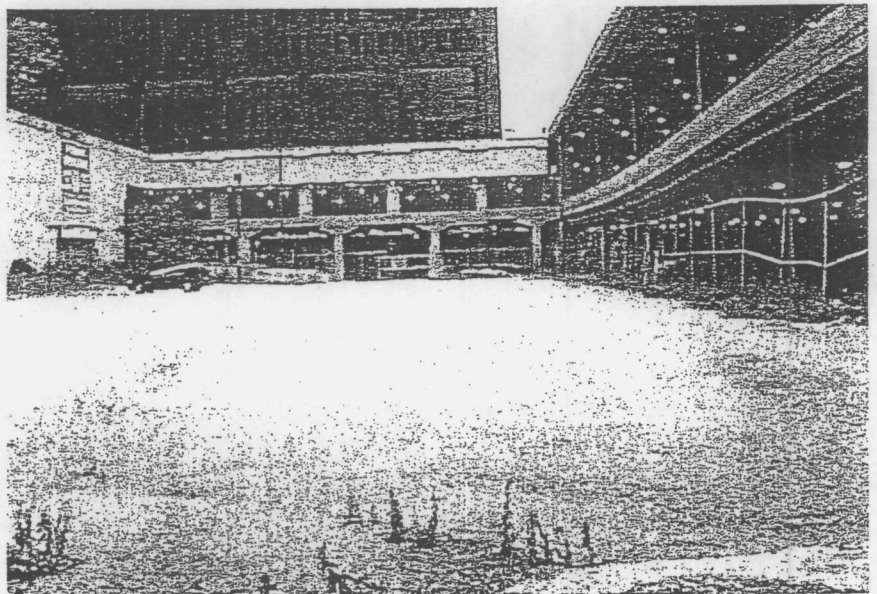
Right: View of Property and  
north and east adjacent sites
